# Hot Dip Galvanizing Appearance: More than Meets the Eye

Corrosion and Sustainability Officer  
Galvanizers Association of Australia

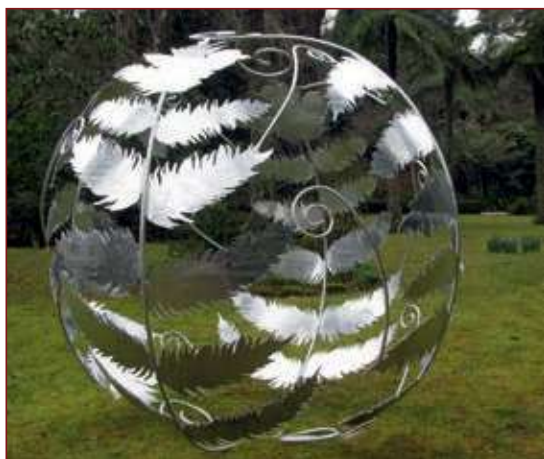
Figure 1 - A shiny new galvanized coating.

Galvanized steel with a **shiny** appearance is the most commonly seen and has become what people expect to see when looking at newly galvanized steel (Figure 1). This shiny appearance is created by the solidification of unreacted zinc on top of zinc-iron alloy layers when it is withdrawn from the zinc bath (Figure 2).

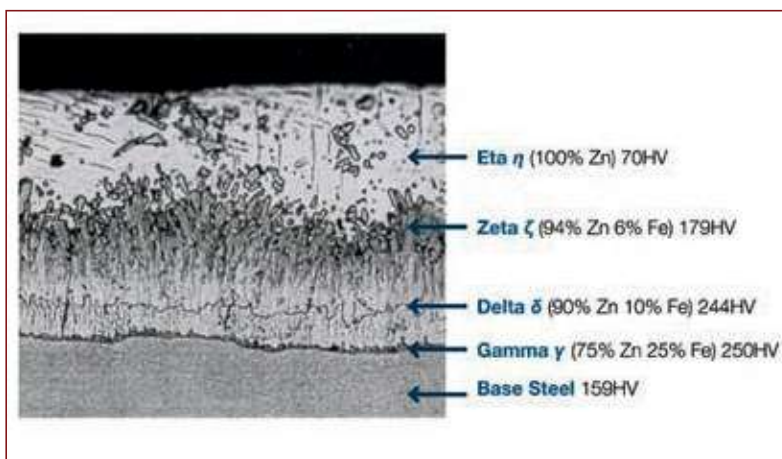
Figure 2 - Typical structure of shiny galvanized coating.

Another appearance one may come across, usually on older galvanized coatings, is what's commonly referred to as bronzing. For a typical shiny coating (whose structure is shown in Figure 2), bronzing will start after the eta layer is consumed and corrosion of the top alloy layer (zeta) starts. As there is a small percentage of iron in the alloy layers, small amounts of iron oxide (rust) are formed on the surface coating, creating a 'bronze' or 'rusty' appearance. This appearance can be confused with rusting of the base steel, however there is always a significant amount of galvanized coating remaining on top of the base steel. One method for determining the difference between bronzing and corrosion of the base steel is to take coating thickness measurements of the area.

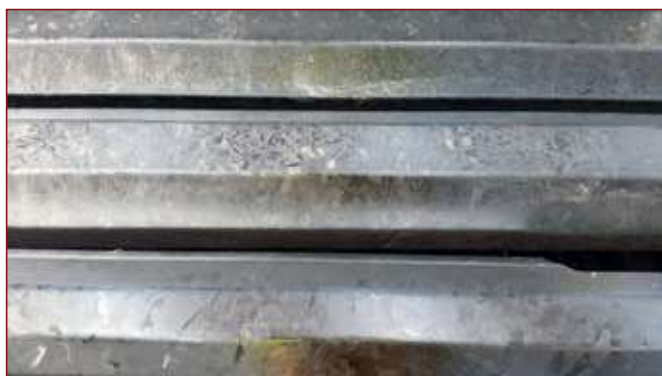
Figure 3 - Spangle pattern on galvanized poles.

A **spangled** appearance has the same general coating structure and lustre as the shiny appearance, with the only difference being how the zinc solidifies. For spangle to form, certain types of additional elements must be present in the zinc to allow the crystalline pattern to form. The concentration of these elements and the cooling rate of the article influence the size and shape of the crystal formation (Figures 3 & 4).

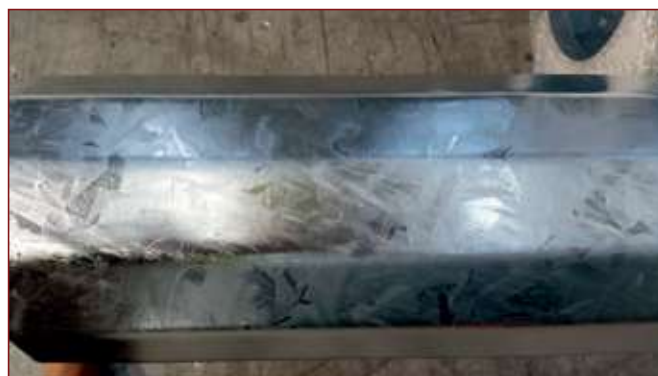
Figure 4 - Large spangle pattern.

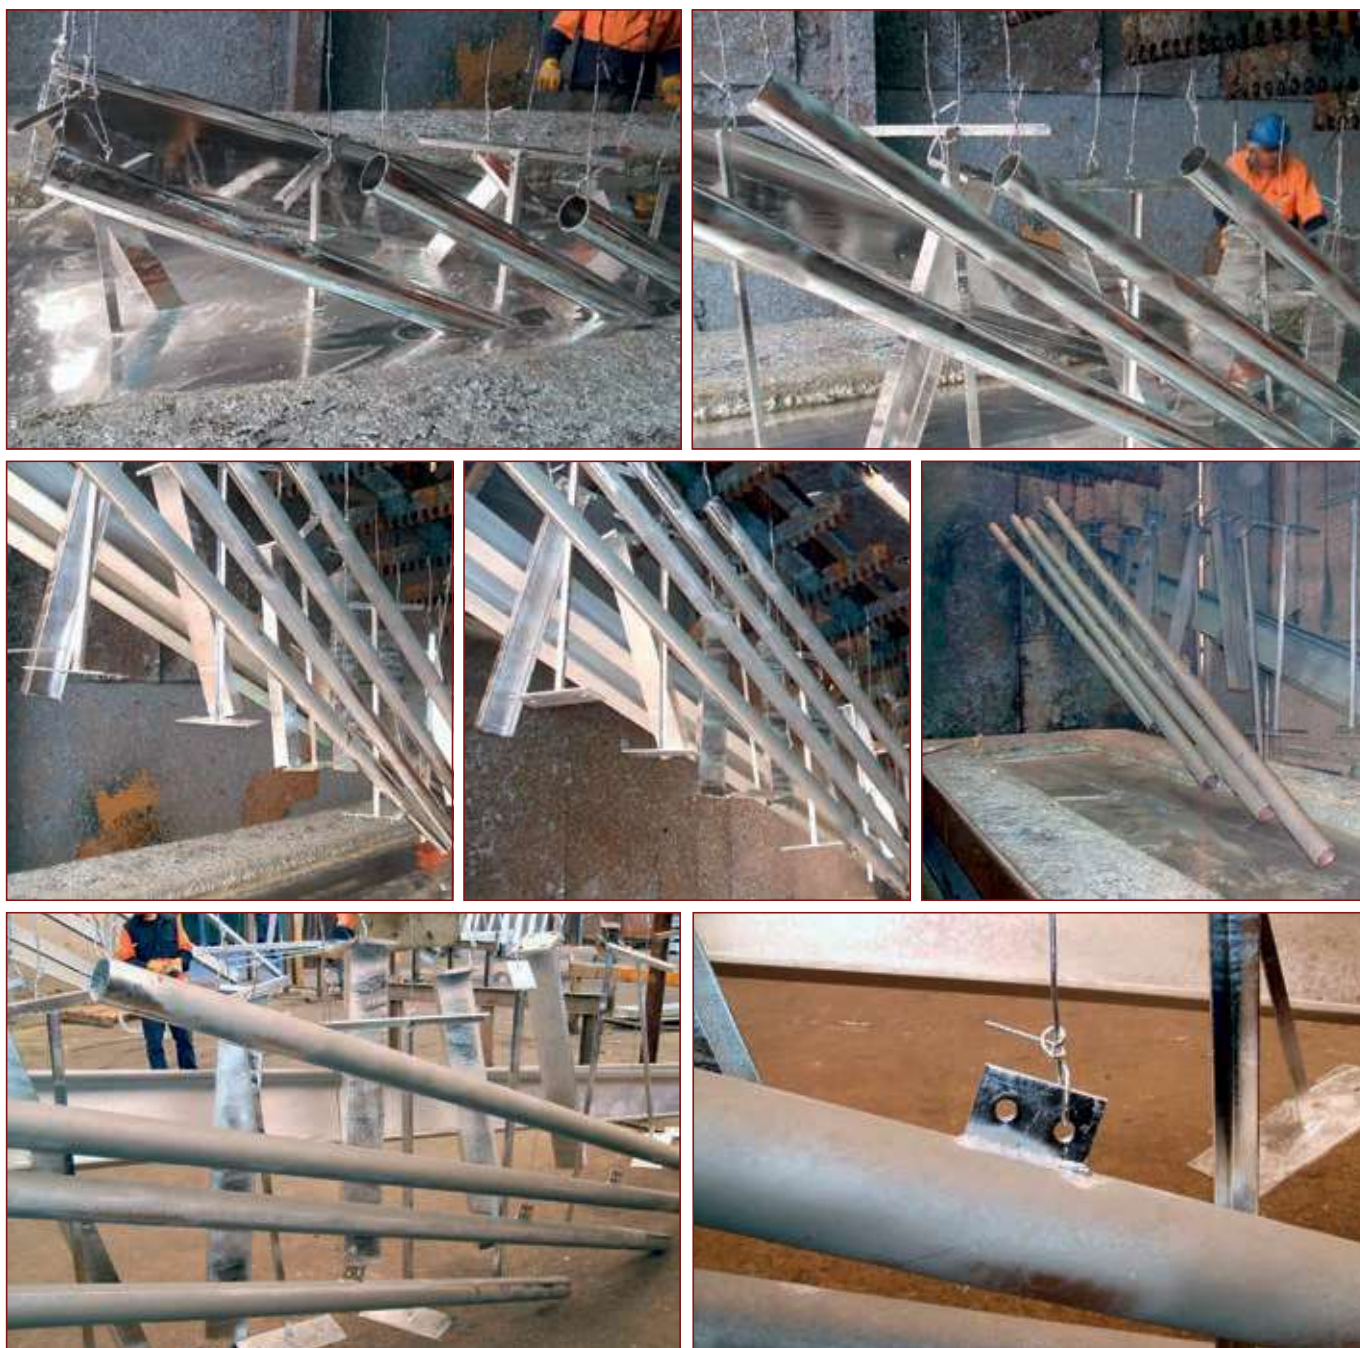
Figure 5 - Dull coating formed as reactive steel pipes are withdrawn from molten zinc.

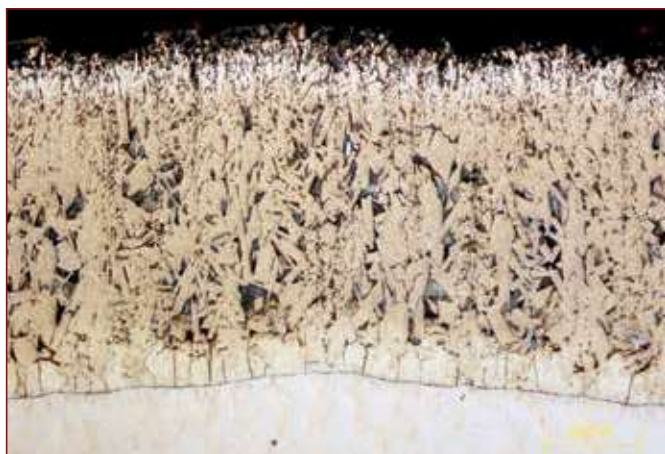
Figure 6 - Micrograph of dull galvanized coating.

initial appearance is due to the coating structure being entirely made of zinc-iron alloy layers, with no top layer of zinc. While there is always zinc pulled up on top of the zinc-iron alloys when an article is withdrawn from the bath, it does not always just solidify in place as with shiny and spangled appearances. Sometimes, the zinc will continue to react with the base iron and be totally converted, leaving only zinc-iron alloy at the coating's surface (Figure 5 and Figure 6). These coatings are usually thicker than their shiny or spangled counterparts and in-turn will have a longer service life when placed in the same environment.

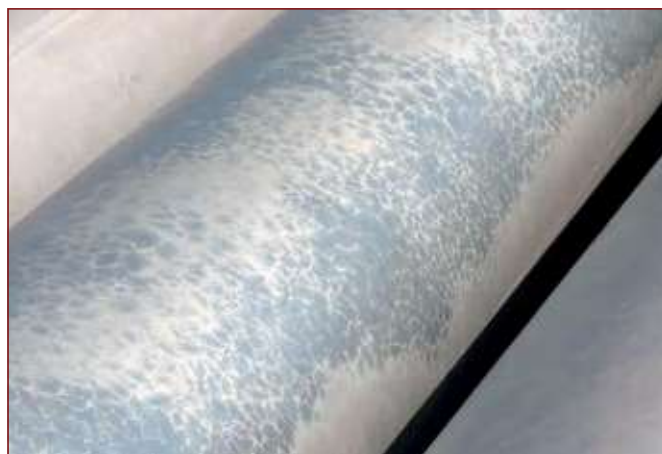
Figure 7 - Galvanizing with mottled appearance.

A **mottled** appearance consists of a dull-grey circular type pattern around areas with a shiny finish (Figure 7). It is also described as a cellular, web (spider web), or mechanical scale pattern and is often mistaken to be the result of cracks in the coating. This appearance occurs due to a partial presence of zinc-iron alloy layers at the surface of the galvanized coating (Figure 8), with the pattern believed to be due to the alloys being created at grain boundaries only and the remaining zinc solidifying without reacting. This appearance may occur in a localised area or extend over the entire surface of an article.

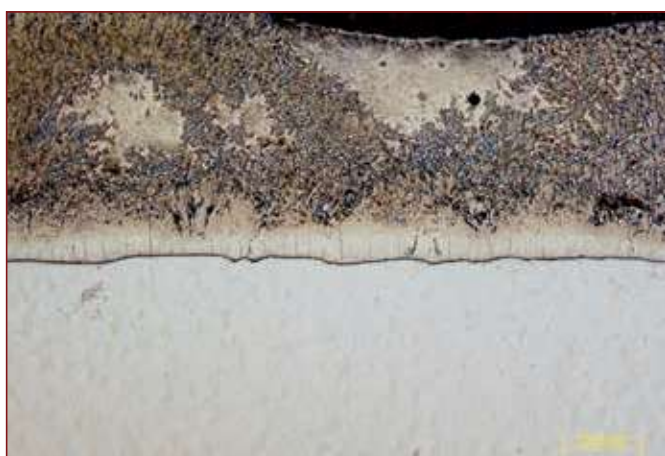
Figure 8 - Micrograph of galvanized coating with partial eta layer.

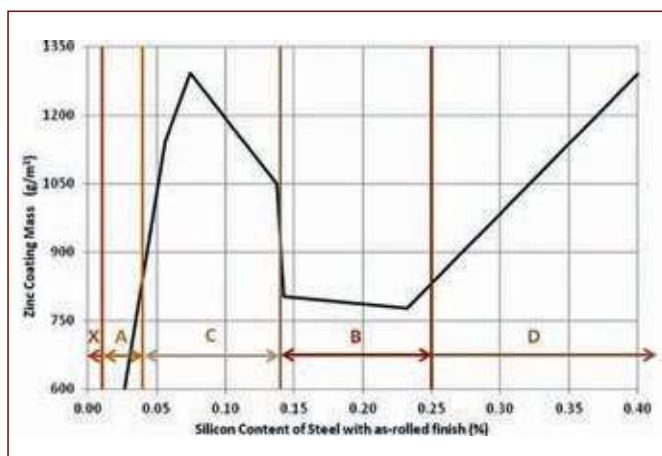
Figure 9 - Sandelin Curve.

Certain elements in the steel, in particular silicon (Si) and phosphorus (P), affect the reactivity of the iron with molten zinc. The extent of the reactivity is dependent on the concentration of each element and this relationship was first described by Sandelin in 1940 (Figure 9). It is now summarised in Table 9.1 of AS/NZS 2312.2 "Guide to the protection of structural steel against atmospheric corrosion by the use of protective coatings - Hot dip galvanizing". The compositions that cause a prolonged or faster rate of reaction between the iron and molten zinc while the steel is submerged are known as 'reactive steels.' These steels usually result in mottled or dull appearances as well as having thicker coatings.

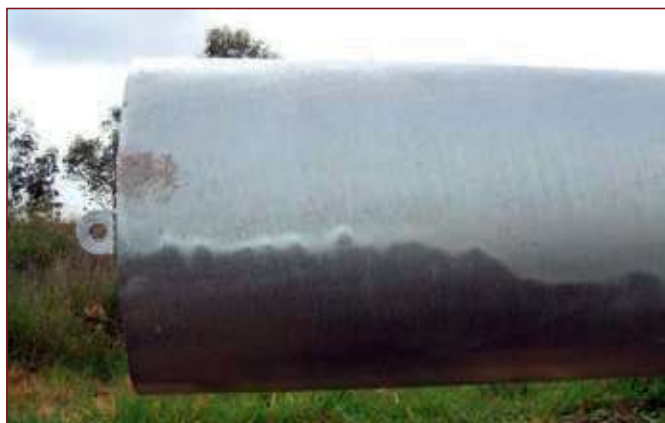
Figure 10 - A partially shiny and dull galvanized coating resulting from the effect of cooling rate.

The thickness of the steel will affect the cooling rate of the steel when it is withdrawn from the molten zinc, with thicker steel retaining heat longer and hence more likely to develop mottled or dull coatings. On large pipes or hollow sections, a difference in appearance can occur across the article due to cooling rate. When the article is being lowered into the quench, straight from the zinc bath, the bottom surface cools quickly and the steam generated from the quench solution travels up and around the top of the section, so it remains at a higher temperature for longer. As a result, the bottom surface retains a shiny pure zinc layer while the zinc and steel on the top half of the member

continues to react, converting the zinc and leaving a dull zinc-iron alloy layers at the surface (Figure 10).

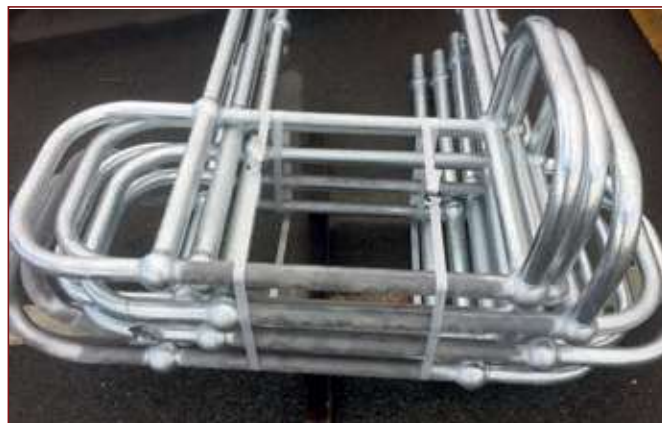
Figure 11 - Steels with significantly different steel composition used in the same fabrication.

Another factor related to design and fabrication that affects appearance is when steels of significantly different chemical composition are used in the one article (Figure 11). This can

lead to completely different initial appearances between adjacent areas, despite the whole article being dipped at the same time.

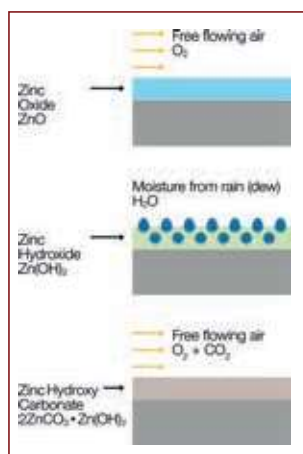
Figure 12 - Schematic of zinc patina formation.

All metals oxidise in the atmosphere and create a passive film on their surface. For zinc, this natural passivation process results in a noticeable change to its appearance and generally occurs in three stages, as shown in Figure 12. The result of this process is the formation of a relatively insoluble zinc carbonate film, known as the patina, which has a matte, light grey colouring. Everyday examples of commonly galvanized objects where this light grey appearance of the patina can generally be observed include handrails (Figure 13), street sign posts, roadside guardrails (Figure 14), and light poles (Figure 15).

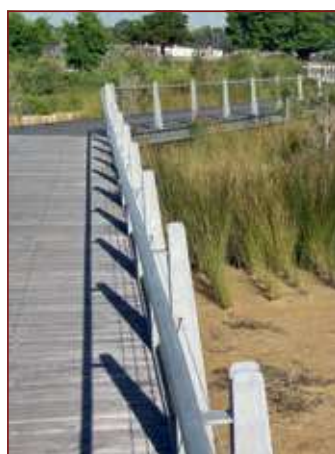
Figure 13 - Galvanized handrail.

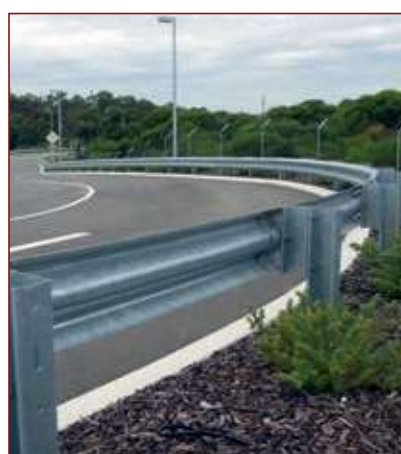
Figure 14 - Galvanized guardrail.

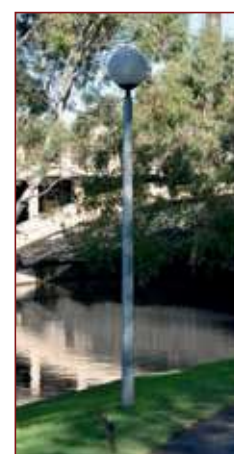
Figure 15 - Galvanized light pole.
